# Access Compliance Report Public Rights-of-Way (Curb Ramps)

| Main Street: ANTONIO_PKWY | | Cross Street: COW_CAMP_RD | | Location: | N |
| ADA ID: RPRK211123131207 | Ramp Type: Type 4 - Parallel | Initial Pass/Fail: Fail | Overall Compliance: No | Severity Score: | 30 |

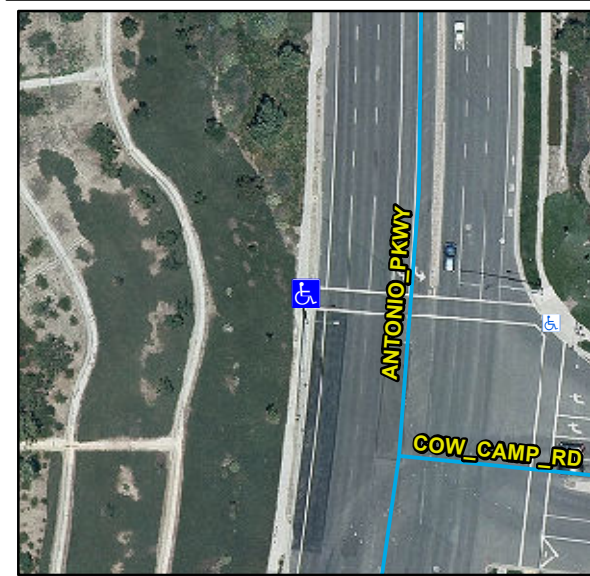
| Compliance | Description | Data | Compliance | Description | Data |
|---|---|---|---|---|---|
| Yes | Ramp Run Slope LT (%) | 4.7 | No | Ramp Run Slope RT (%) | 16.1 |

Possible Solutions:

**Remove & Replace Entire Ramp.**

R304.3.2, STD 1115

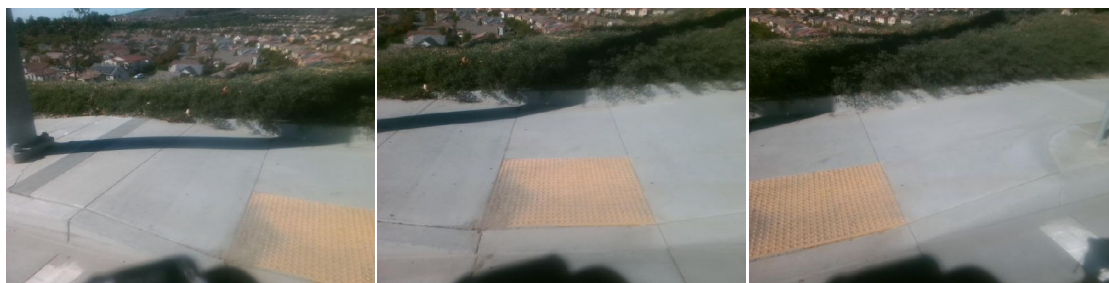
| Compliance | Description | Data | Compliance | Description | Data |
|---|---|---|---|---|---|
| Yes | Overall Surface Condition | Acceptable | | | |
