# Access Compliance Report Public Rights-of-Way (Curb Ramps)

| Main Street: COW_CAMP_RD | | Cross Street: CHIQUITA_CANYON_DR | | Location: | S |
| ADA ID: RPRK211124121020 | Ramp Type: Type 1 - Perpendicular | Initial Pass/Fail: Pass | Overall Compliance: No | Severity Score: | 10 |

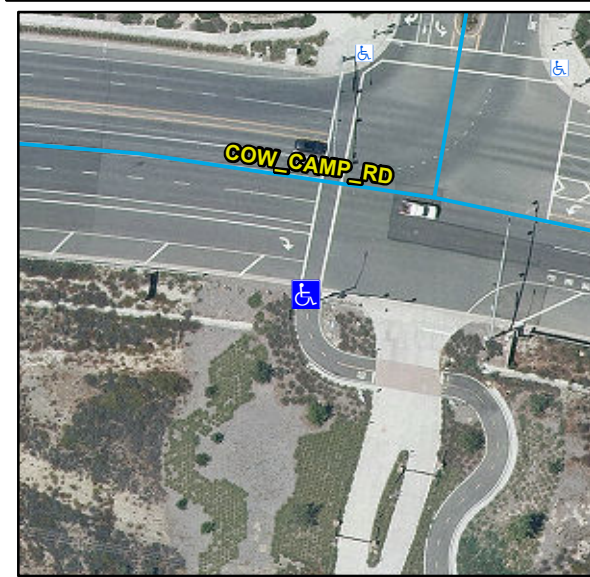
| Compliance | Description | Data | Compliance | Description | Data |
|---|---|---|---|---|---|
| N/A | Landing Present | No | Yes | Flare Type RT | Curbed2 |
| No | Landing Width (in) | N/A | N/A | Flare Slope RT (%) | N/A |
| No | Landing Run Slope (%) | N/A | N/A | Flare Traversable RT | N/A |
| No | Landing Cross Slope (%) | N/A | Yes | DWS Provided | Yes |
| No | Gutter Ponding | Yes | Yes | Curb Slope | 0.3 |
| No | Gutter Cross Slope (%) | 2.2 | | | |

Possible Solutions:

Install Landing. Remove & Replace Gutter.

R304.2.1, R304.2.2-Perp, R304.3.2-Para, R304.5.3, R302.7, STD 1115
