# Access Compliance Report Public Rights-of-Way (Curb Ramps)

Main Street: COW\_CAMP\_RD Cross Street: CHIQUITA\_CANYON\_DR Location: N

ADA ID: RPRK211124121535 Ramp Type: Type 1 - Perpendicular Diagonal Initial Pass/Fail: Pass Overall Compliance: No Severity Score: 2

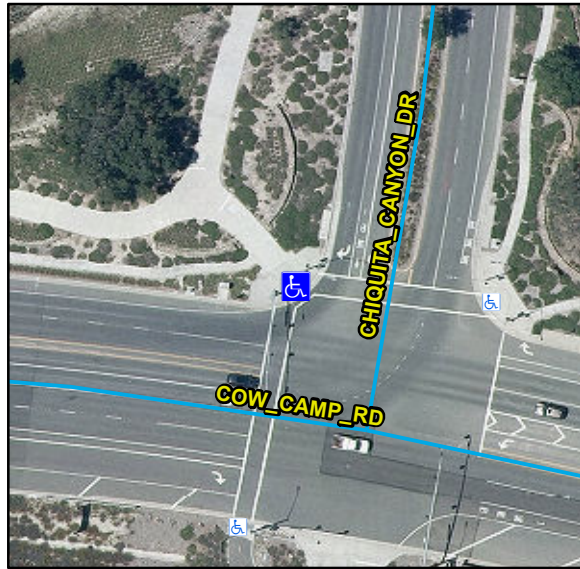
| Compliance | Description | Data | Compliance | Description | Data |
|---|---|---|---|---|---|
| No | Landing Run Slope (%) | 3.5 | N/A | Flare Traversable RT | Yes |
| Yes | Gutter Ponding | No | No | Curb Slope | 9.9 |

Remove & Replace Curb Ramp With Two New Directional Ramps or Equivalent.

R304.2.2, R304.2.2-Perp, R304.3.2-Para, STD 1115
