# Access Compliance Report Public Rights-of-Way (Curb Ramps)

Main Street: CHIQUITA\_CANYON\_DR Cross Street: COW\_CAMP\_RD Location: NE

ADA ID: RPRK211124122212 Ramp Type: Type 1 - Perpendicular Diagonal Initial Pass/Fail: Fail Overall Compliance: No Severity Score: 16

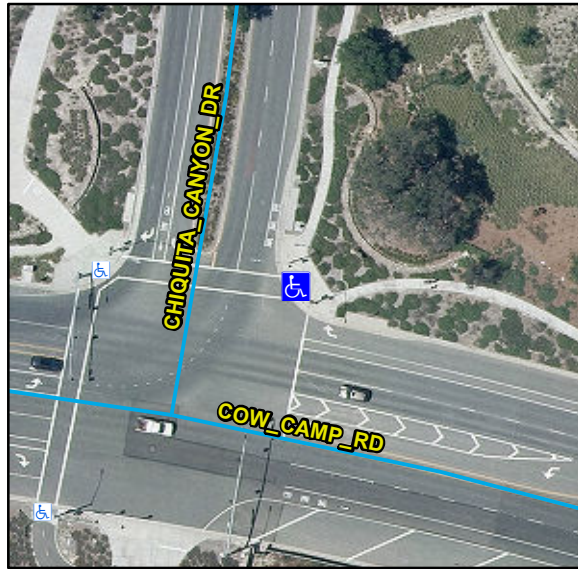
| Compliance | Description | Data | Compliance | Description | Data |
|---|---|---|---|---|---|
| No | Ramp Run Slope (%) | 8.8 | N/A | Flare Slope LT (%) | N/A |

Remove & Replace Curb Ramp With Two New Directional Ramps or Equivalent.

R304.2.2, STD 1115
