# Access Compliance Report Public Rights-of-Way (Curb Ramps)

| Main Street: FAUNA_DR | | Cross Street: CHIQUITA_CANYON_DR | | Location: | E |
| ADA ID: RPRK211124123029 | Ramp Type: Type 1 - Perpendicular | Initial Pass/Fail: Pass | Overall Compliance: No | Severity Score: | 12 |

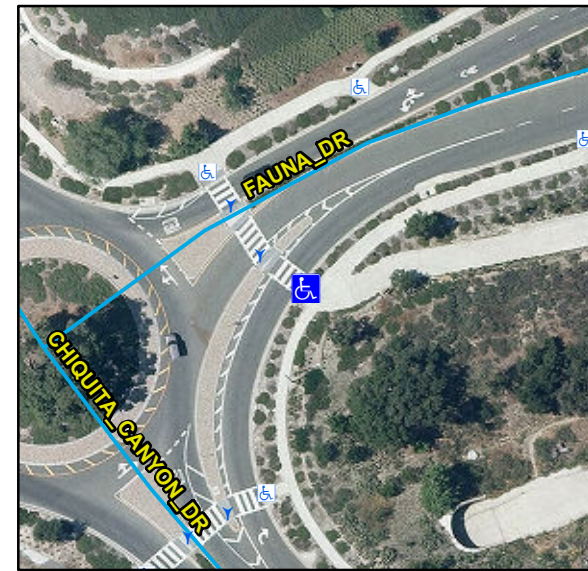
| Compliance | Description | Data | Compliance | Description | Data |
|---|---|---|---|---|---|
| No | Landing Run Slope (%) | 5.6 | N/A | Flare Traversable RT | N/A |
| No | Gutter Run Slope (%) | 8.9 | | Road Cross Slope (%) | N/A |
| No | Gutter Cross Slope (%) | 2.7 | | | |

**Remove & Replace Landing. Remove & Replace Gutter.**
