# Access Compliance Report Public Rights-of-Way (Curb Ramps)

| Main Street: FAUNA_DR | | Cross Street: FAUNA_DR | | Location: | S |
| ADA ID: RPRK211124123529 | Ramp Type: Type 6 - Directional 1 | Initial Pass/Fail: Fail | Overall Compliance: No | Severity Score: | 16 |

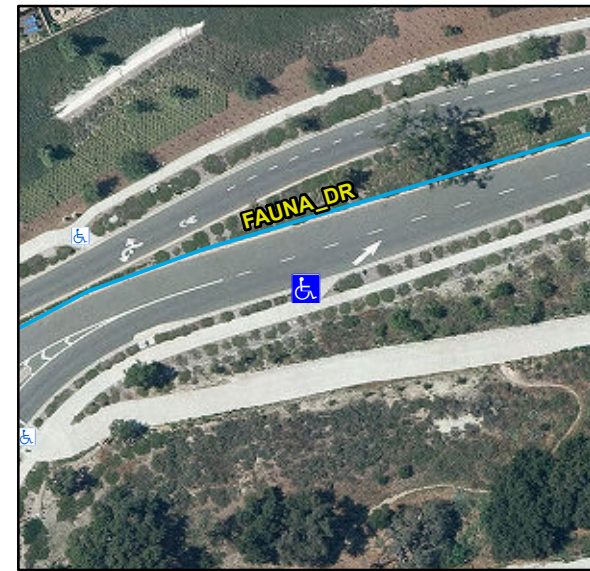
| Compliance | Description | Data | Compliance | Description | Data |
|---|---|---|---|---|---|
| No | Ramp Run Slope (%) | 9.5 | N/A | Flare Slope LT (%) | N/A |
| No | Ramp Cross Slope (%) | 2.4 | N/A | Flare Traversable LT | N/A |

**Remove & Replace Entire Ramp.**

**R204.3, R304.2.2, R304.5.3, STD 1115**

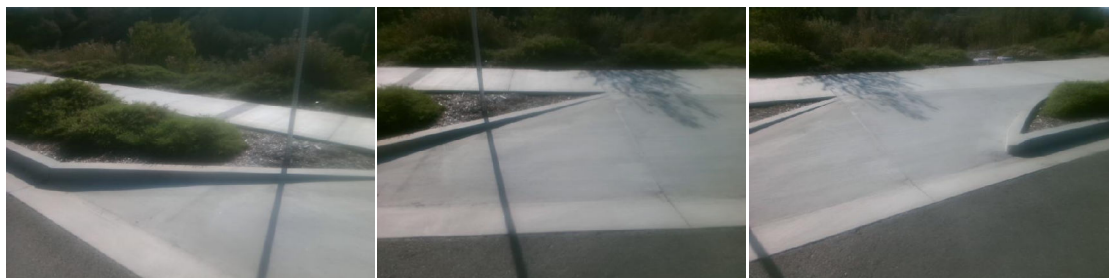
| Compliance | Description | Data | Compliance | Description | Data |
|---|---|---|---|---|---|
| N/A | Ramp Length (in) | 104 | N/A | Flare Type LT | |
| Yes | Ramp Width (in) | 208 | | | N/A |

Possible Solutions:
