# Access Compliance Report Public Rights-of-Way (Curb Ramps)

Main Street: FAUNA\_DR Cross Street: FAUNA\_DR Location: N

ADA ID: RPRK211124123716 Ramp Type: Type 6 - Directional 1 Initial Pass/Fail: Fail Overall Compliance: No Severity Score: 2

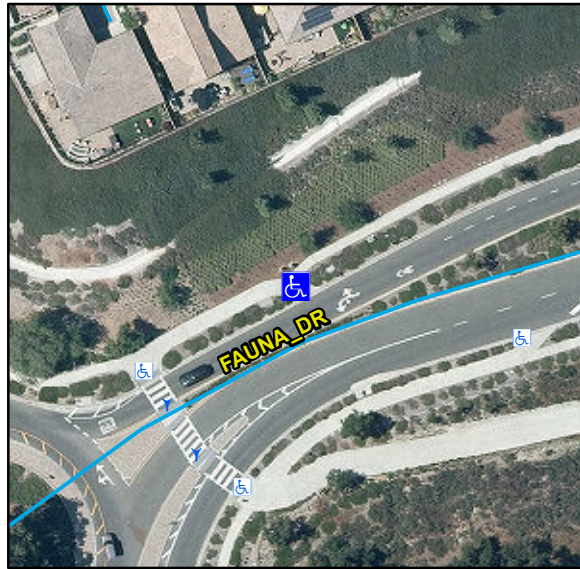
| Compliance | Description | Data | Compliance | Description | Data |
|---|---|---|---|---|---|
| No | Ramp Cross Slope (%) | 2.2 | N/A | Flare Traversable LT | N/A |

Possible Solutions:

Remove & Replace Entire Ramp.

R204.3, R304.5.3, STD 1115
