# Access Compliance Report Public Rights-of-Way (Curb Ramps)

| Main Street: FAUNA_DR | | Cross Street: CHIQUITA_CANYON_DR | | Location: | E |
| ADA ID: RPRK211124123902 | Ramp Type: Type 1 - Perpendicular | Initial Pass/Fail: Pass | Overall Compliance: No | Severity Score: | 5 |

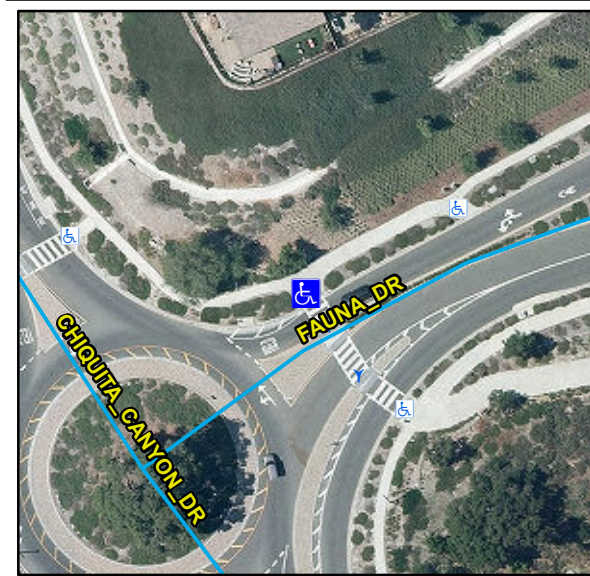
| Compliance | Description | Data | Compliance | Description | Data |
|---|---|---|---|---|---|
| No | Gutter Run Slope (%) | 9.3 | | Road Cross Slope (%) | N/A |

Possible Solutions:

Remove & Replace Gutter.

R304.5.4, STD 1115
