# Access Compliance Report Public Rights-of-Way (Curb Ramps)

| Main Street: CHIQUITA_CANYON_DR | | Cross Street: FAUNA_DR | | Location: | S |

| ADA ID: RPRK211124125053 | Ramp Type: Type 1 - Perpendicular | Initial Pass/Fail: Pass | Overall Compliance: No | Severity Score: | 2 |

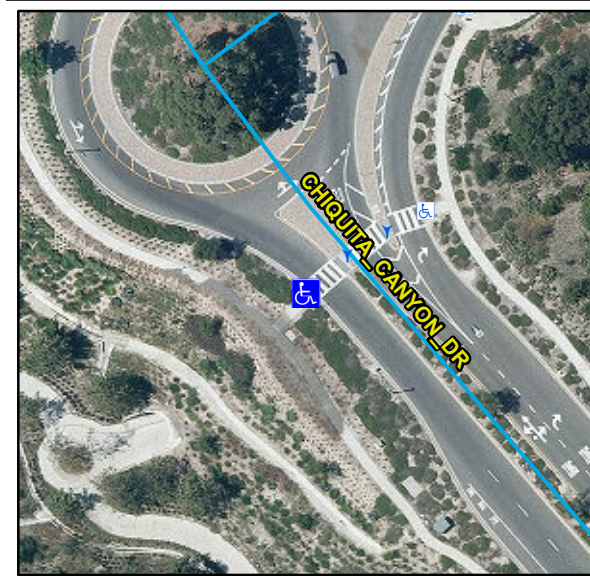
| Compliance | Description | Data | Compliance | Description | Data |
|---|---|---|---|---|---|
| Yes | Gutter Ponding | No | No | Curb Slope | 7.8 |

Possible Solutions:

**Remove & Replace Curb Slope.**

**R304.2.2, STD 1115**

Total Cost: \$ 252
