# Access Compliance Report Public Rights-of-Way (Curb Ramps)

| Main Street: CHIQUITA_CANYON_DR | | Cross Street: FAUNA_DR | | Location: | S |
| ADA ID: RPRK211124125842 | Ramp Type:Type 1 - Perpendicular | Initial Pass/Fail: Pass | Overall Compliance: Yes | Severity Score: | 0 |

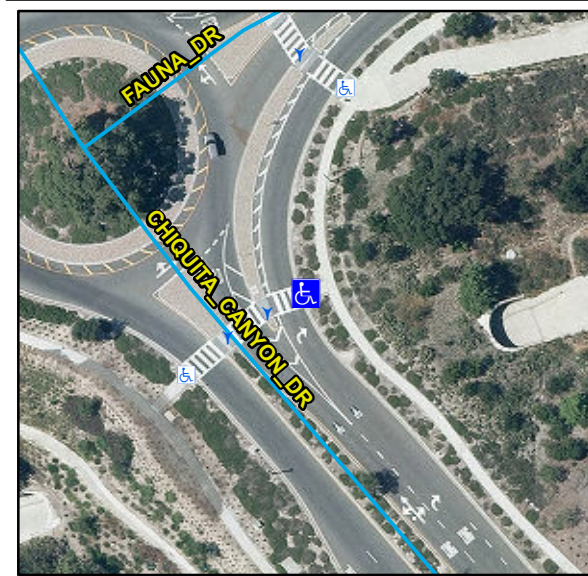
| Compliance | Description | Data | Compliance | Description | Data |
|---|---|---|---|---|---|
| Yes | Overall Surface Condition: Acceptable | | Yes | Perp Joint Present | Yes |

Possible Solutions:

N/A
