# Access Compliance Report Public Rights-of-Way (Curb Ramps)

Main Street: AIROSO\_ST Cross Street: CHIQUITA\_CANYON\_DR Location: E

ADA ID: RPRK211124130316 Ramp Type: Type 1 - Perpendicular Initial Pass/Fail: Pass Overall Compliance: No Severity Score: 0

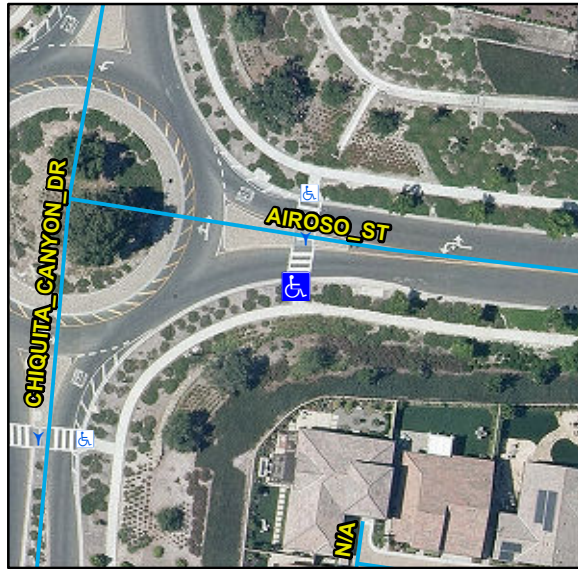
| Compliance | Description | Data | Compliance | Description | Data |
|---|---|---|---|---|---|
| No | Landing Cross Slope (%) | 3.2 | Yes | DWS Provided | Yes |
| Yes | Gutter Ponding | No | No | Curb Slope | 11.8 |
| No | Gutter Cross Slope (%) | 3.7 | | | |

Remove & Replace Entire Ramp. Remove & Replace Gutter.

R304.2.2, R304.5.3, STD 1115
