# Access Compliance Report Public Rights-of-Way (Curb Ramps)

Main Street: AIROSO\_ST Cross Street: CHIQUITA\_CANYON\_DR Location: E

ADA ID: RPRK211124130712 Ramp Type: Type 1 - Perpendicular Initial Pass/Fail: Fail Overall Compliance: No Severity Score: 2

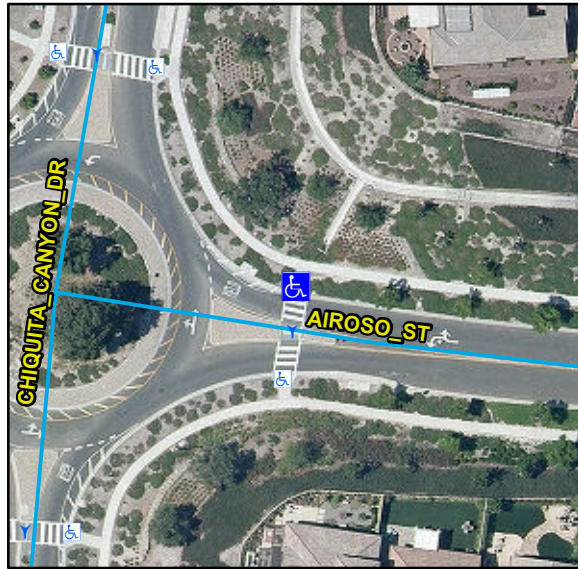
| Compliance | Description | Data | Compliance | Description | Data |
|---|---|---|---|---|---|
| No | Ramp Cross Slope (%) | 2.5 | N/A | Flare Traversable LT | N/A |

Remove & Replace Entire Ramp.
