# Access Compliance Report Public Rights-of-Way (Curb Ramps)

| Main Street: CHIQUITA_CANYON_DR | | Cross Street: AIROSO_ST | | Location: | N |
| ADA ID: RPRK211124131128 | Ramp Type:Type 1 - Perpendicular | Initial Pass/Fail: Fail | Overall Compliance: No | Severity Score: | 2 |

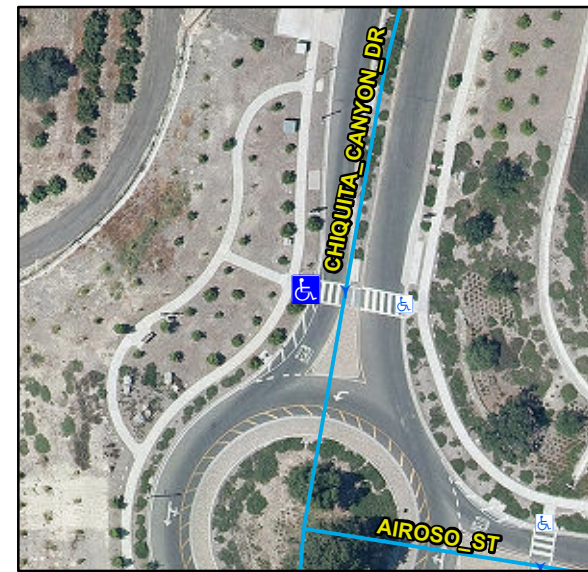
R304.2.2, R304.5.3, STD 1115

| Compliance | Description | Data | Compliance | Description | Data |
|---|---|---|---|---|---|
| No | Ramp Cross Slope (%) | 2.4 | N/A | Flare Traversable LT | N/A |

Remove & Replace Entire Ramp.

Total Cost: \$ 3080
