# Access Compliance Report Public Rights-of-Way (Curb Ramps)

Main Street: CHIQUITA\_CANYON\_DR Cross Street: AIROSO\_ST Location: S

ADA ID: RPRK211124131623 Ramp Type: Type 1 - Perpendicular Initial Pass/Fail: Fail Overall Compliance: No Severity Score: 2

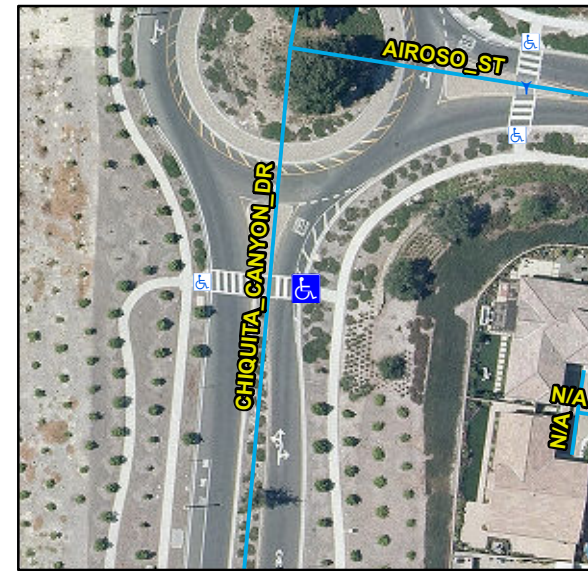
R304.2.2, R304.5.3, STD 1115

| Compliance | Description | Data | Compliance | Description | Data |
|---|---|---|---|---|---|
| No | Ramp Cross Slope (%) | 3.6 | N/A | Flare Traversable LT | N/A |

Remove & Replace Entire Ramp.

Total Cost: \$ 3080
