# Access Compliance Report Public Rights-of-Way (Curb Ramps)

| Main Street: CHIQUITA_CANYON_DR | | Cross Street: ESENCIA_DR | | Location: | NW |
| ADA ID: RPRK211124132249 | Ramp Type:Type 1 - Perpendicular Diagonal Initial Pass/Fail: Fail | | Overall Compliance: No | Severity Score: | 2 |

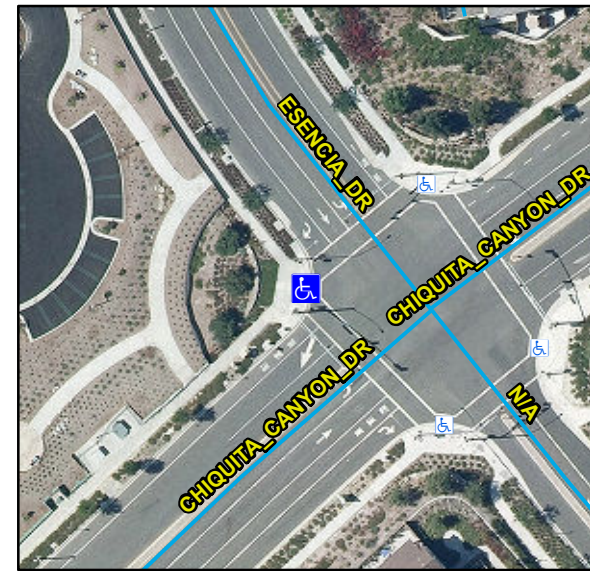
**R304.2.2, R304.5.3, STD 1115**

| Compliance | Description | Data | Compliance | Description | Data |
|---|---|---|---|---|---|
| No | Ramp Cross Slope (%) | 3.7 | N/A | Flare Traversable LT | N/A |

**Remove & Replace Curb Ramp With Two New Directional Ramps or Equivalent.**

Total Cost: \$ 6160
