# Access Compliance Report Public Rights-of-Way (Curb Ramps)

Main Street: CHIQUITA\_CANYON\_DR Cross Street: CHIQUITA\_CANYON\_DR Location: SW

ADA ID: RPRK211124132735 Ramp Type: Type 1 - Perpendicular Diagonal Initial Pass/Fail: Pass Overall Compliance: No Severity Score: 9

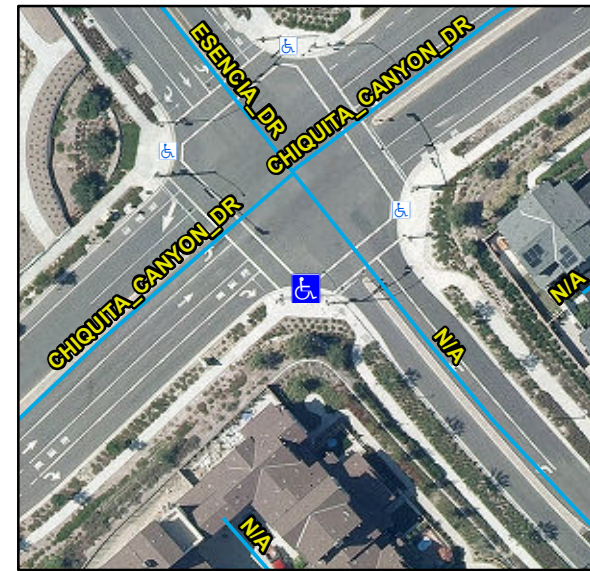
| Compliance | Description | Data | Compliance | Description | Data |
|---|---|---|---|---|---|
| Yes | Gutter Ponding | No | No | Curb Slope | 5.1 |
| No | Gutter Run Slope (%) | 5.4 | | Road Cross Slope (%) | 6.6 |

Remove & Replace Curb Ramp With Two New Directional Ramps or Equivalent. Remove & Replace Gutter.

R304.2.2, R304.2.1, R304.5.4, STD 1115
