# Access Compliance Report Public Rights-of-Way (Curb Ramps)

Main Street: CHIQUITA\_CANYON\_DR Cross Street: N/A Location: SE

ADA ID: RPRK211124133238 Ramp Type: Type 1 - Perpendicular Diagonal Initial Pass/Fail: Pass Overall Compliance: No Severity Score: 5

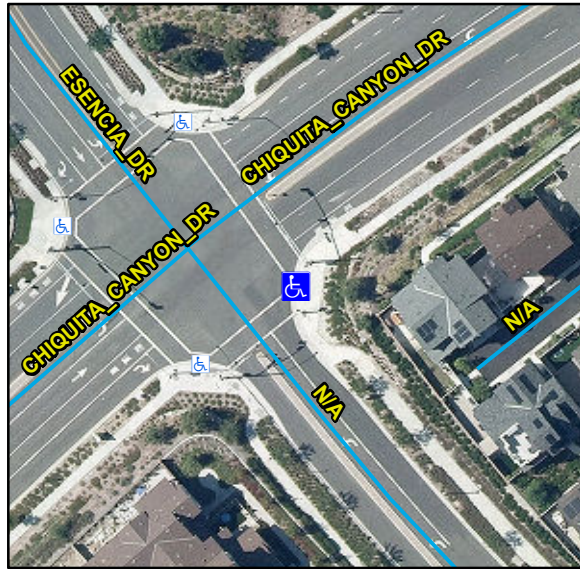
| Compliance | Description | Data | Compliance | Description | Data |
|---|---|---|---|---|---|
| Yes | Gutter Ponding | No | No | Curb Slope | 6.1 |
| No | Gutter Run Slope (%) | 5.5 | | Road Cross Slope (%) | 6.1 |

Remove & Replace Curb Slope. Remove & Replace Gutter.

R304.2.2, R304.5.4, STD 1115
