# Access Compliance Report Public Rights-of-Way (Curb Ramps)

Main Street: **SUERTE\_ST** Cross Street: **MEDANO\_ST** Location: **S**

ADA ID: **RPRK211124134801** Ramp Type: **Type 1 - Perpendicular** Initial Pass/Fail: **Pass** Overall Compliance: **No** Severity Score: **5**

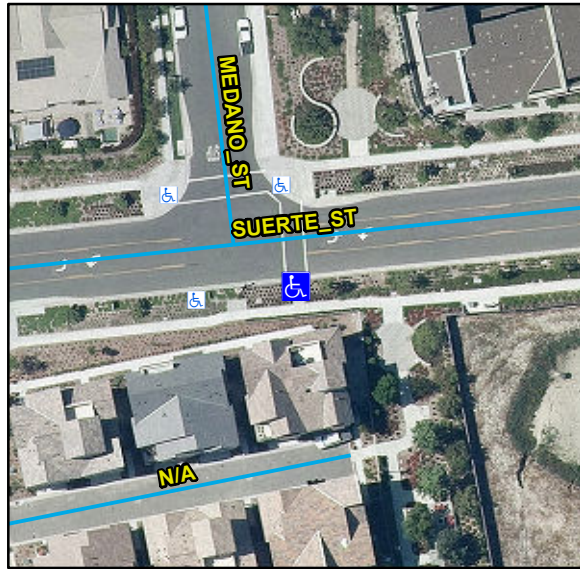
Compliance	Description	Data	Compliance	Description	Data
N/A	Ramp Length (in)	153	N/A	Flare Type LT	
Yes	Ramp Width (in)	60		Flare Slope LT (%)	18.6
Yes	Ramp Run Slope (%)	4	N/A	Flare Traversable LT	No
Yes	Ramp Cross Slope (%)	1.2	N/A	Flare Type RT	
N/A	Landing Present	Yes		Flare Slope RT (%)	8.6
N/A	Landing Length (in)	60		Flare Traversable RT	No
Yes	Landing Width (in)	66	N/A	DWS Provided	Yes
Yes	Landing Run Slope (%)	0.7	N/A	DWS Contrast	Yes
Yes	Landing Cross Slope (%)	1	Yes	DWS Length (in)	36
N/A	Landing Movement Obstructed?	No	Yes	DWS Full Width	Yes
	Landing Movement Type	N/A	Yes	DWS Offset Left (in)	0
N/A	Landing Shared	No	Yes	DWS Offset Right (in)	N/A
N/A	Clear Space	N/A	N/A	Marked Crosswalk 1	Yes
N/A	Clear Space To Crosswalk (in)	N/A	Yes	Marked Crosswalk 2	N/A
N/A	Marked Crosswalk 1	Yes	N/A	Crossing 1 Direction	N
	Crossing 1 Direction	N		Crossing 2 Direction	N/A
	Marked Crosswalk 1 Width (in)	144		Marked Crosswalk 2 Width (in)	N/A

Yes	Ramp Inside Crosswalk 1	Yes	Yes	Ramp Inside Crosswalk 2	N/A
	Crossing 1 Slope (%)	5.7		Crossing 2 Slope (%)	N/A
	Crossing 1 Cross Slope (%)	3.2		Crossing 2 Cross Slope (%)	N/A
Yes	Gutter Ponding	No	No	Curb Slope	7.7
Yes	Gutter Lip Height (in)	0		Road Run Slope (%)	N/A
No	Gutter Run Slope (%)	6.4		Road Cross Slope (%)	N/A
Yes	Gutter Cross Slope (%)	2.6			
Yes	Overall Surface Condition: <b>Acceptable</b>		Yes	Perp Joint Present	Yes
	Cross Gutter Present?	No		Spandrel Present?	No
	Replace Cross Gutter?	N/A		Replace Spandrel?	N/A

Possible Solutions:  
**Remove & Replace Curb Slope. Remove & Replace Gutter.**

OC Std/PROW:  
**R304.2.2, R304.5.4, STD 1115**
