# Access Compliance Report Public Rights-of-Way (Curb Ramps)

Main Street: MEDANO\_ST Cross Street: SUERTE\_ST Location: NE

ADA ID: RPRK211124135006 Ramp Type: Type 1 - Perpendicular Diagonal Initial Pass/Fail: Fail Overall Compliance: No Severity Score: 2

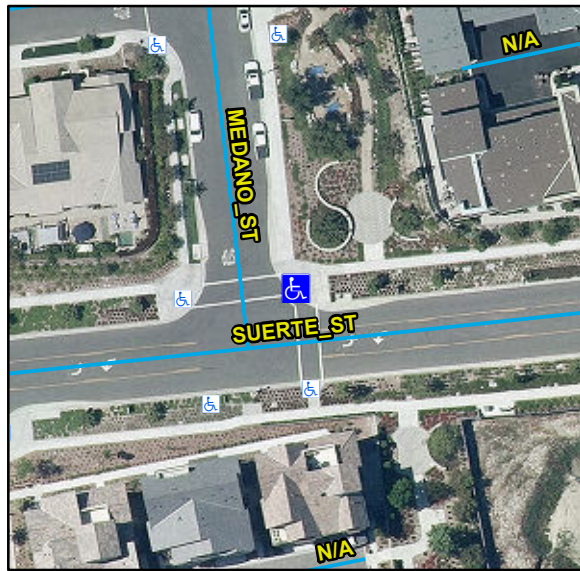
| Compliance | Description | Data | Compliance | Description | Data |
|---|---|---|---|---|---|
| No | Ramp Cross Slope (%) | 3.6 | N/A | Flare Traversable LT | N/A |

Remove & Replace Curb Ramp With Two New Directional Ramps or Equivalent.

R304.2.2, R304.5.3, STD 1115
