# Access Compliance Report Public Rights-of-Way (Curb Ramps)

Main Street: SUERTE\_ST Cross Street: MEDANO\_ST Location: NW

ADA ID: RPRK211124135145 Ramp Type: Type 1 - Perpendicular Diagonal Initial Pass/Fail: Fail Overall Compliance: No Severity Score: 2

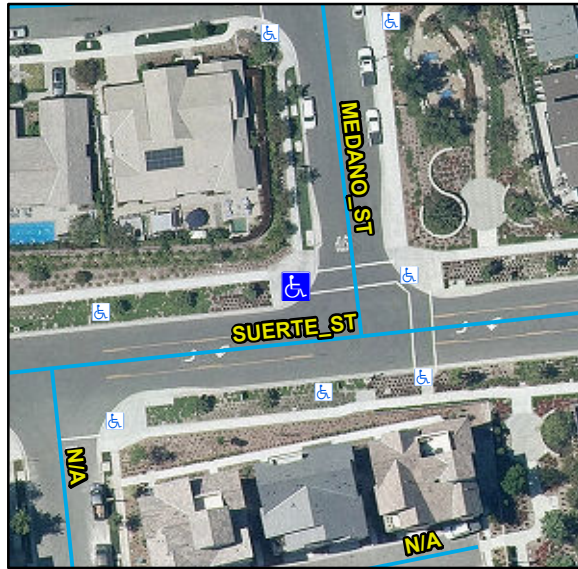
| Compliance | Description | Data | Compliance | Description | Data |
|---|---|---|---|---|---|
| No | Ramp Cross Slope (%) | 3 | N/A | Flare Traversable LT | N/A |
| N/A | Gutter Ponding | N/A | No | Curb Slope | 12.9 |

Remove & Replace Curb Ramp With Two New Directional Ramps or Equivalent.

R304.2.2, R304.5.3, STD 1115
