# Access Compliance Report Public Rights-of-Way (Curb Ramps)

Main Street: TOPAZ\_ST Cross Street: MEDANO\_ST Location: NW

ADA ID: RPRK211124135605 Ramp Type: Type 4 - Parallel Initial Pass/Fail: Fail Overall Compliance: No Severity Score: 2

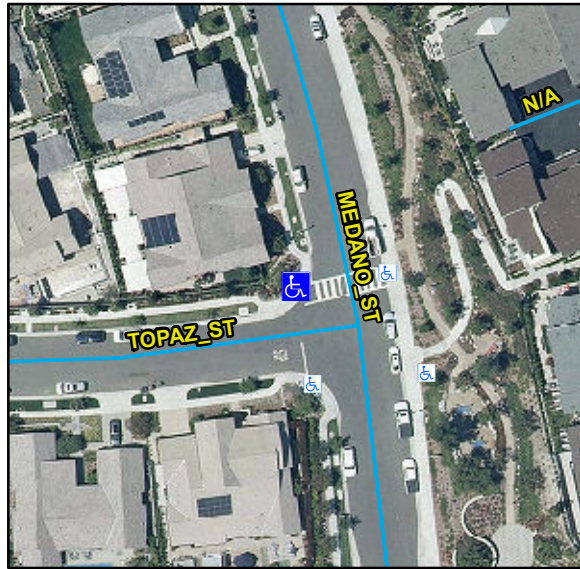
| Compliance | Description | Data | Compliance | Description | Data |
|---|---|---|---|---|---|
| No | Ramp Cross Slope LT (%) | 2.6 | Yes | Ramp Cross Slope RT (%) | 0.8 |

Remove & Replace Curb Ramp With Two New Directional Ramps or Equivalent.

R304.5.3, STD 1115
