# Access Compliance Report Public Rights-of-Way (Curb Ramps)

Main Street: SUERTE\_ST Cross Street: N/A Location: SE

ADA ID: RPRK211124140101 Ramp Type: Type 1 - Perpendicular Diagonal Initial Pass/Fail: Fail Overall Compliance: No Severity Score: 2

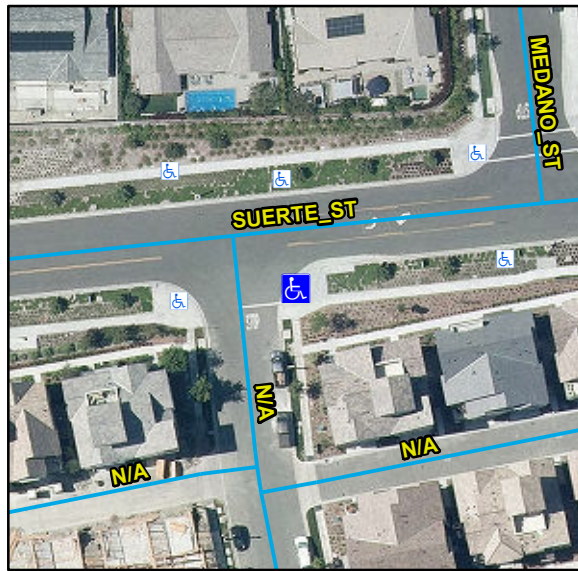
| Compliance | Description | Data | Compliance | Description | Data |
|---|---|---|---|---|---|
| No | Ramp Cross Slope (%) | 2.2 | N/A | Flare Traversable LT | N/A |

Remove & Replace Curb Ramp With Two New Directional Ramps or Equivalent.

R304.2.2, R304.5.3, STD 1115
