# Access Compliance Report Public Rights-of-Way (Curb Ramps)

Main Street: N/A Cross Street: SUERTE\_ST Location: SW

ADA ID: RPRK211124140248 Ramp Type: Type 1 - Perpendicular Diagonal Initial Pass/Fail: Pass Overall Compliance: No Severity Score: 0

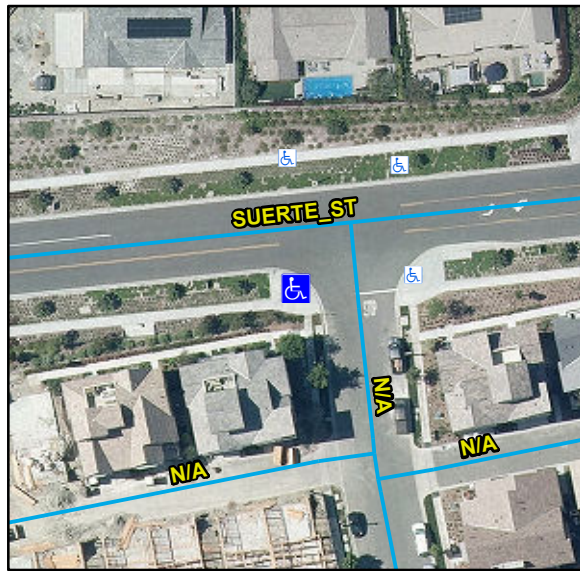
| Compliance | Description | Data | Compliance | Description | Data |
|---|---|---|---|---|---|
| Yes | Gutter Ponding | No | No | Curb Slope | 7 |
| No | Gutter Cross Slope (%) | 2.8 | | | |

Remove & Replace Curb Slope. Remove & Replace Gutter.

R304.2.2, R304.5.3, STD 1115

Total Cost: \$ 504
