# Access Compliance Report Public Rights-of-Way (Curb Ramps)

Main Street: SUERTE\_ST Cross Street: ESENCIA\_DR Location: SE

ADA ID: RPRK211124140536 Ramp Type: Type 1 - Perpendicular Diagonal Initial Pass/Fail: Fail Overall Compliance: No Severity Score: 2

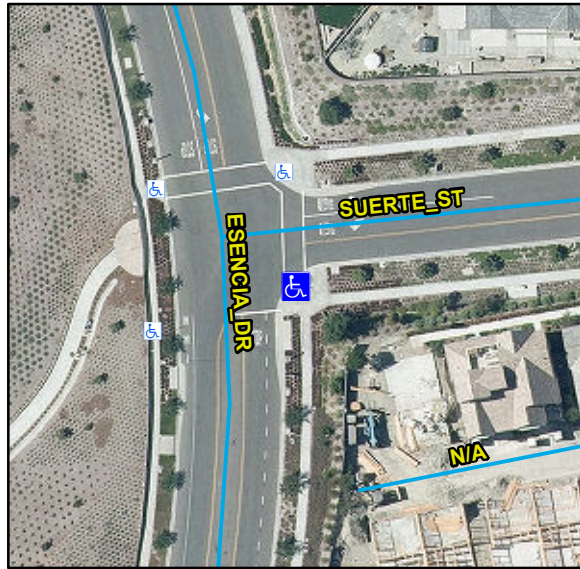
R304.2.2, R304.5.3, STD 1115

| Compliance | Description | Data | Compliance | Description | Data |
|---|---|---|---|---|---|
| No | Ramp Cross Slope (%) | 4.4 | N/A | Flare Traversable LT | N/A |

Remove & Replace Curb Ramp With Two New Directional Ramps or Equivalent.
