# Access Compliance Report Public Rights-of-Way (Curb Ramps)

Main Street: ESENCIA\_DR Cross Street: SUERTE\_ST Location: NE

ADA ID: RPRK211124140806 Ramp Type: Type 1 - Perpendicular Diagonal Initial Pass/Fail: Fail Overall Compliance: No Severity Score: 2

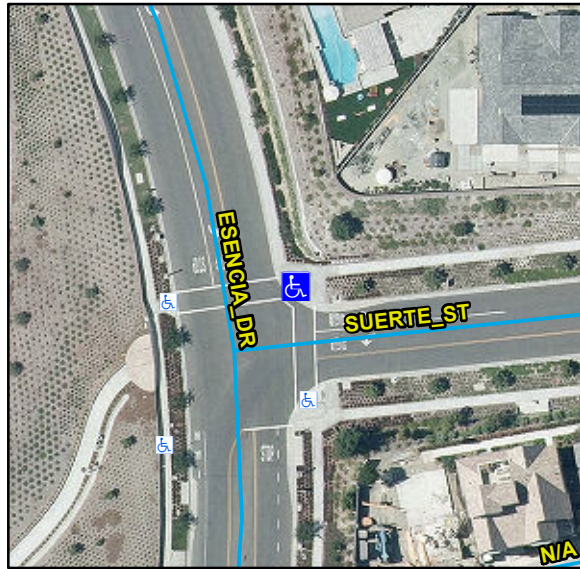
| Compliance | Description | Data | Compliance | Description | Data |
|---|---|---|---|---|---|
| No | Ramp Cross Slope (%) | 4.3 | N/A | Flare Traversable LT | N/A |
| N/A | Gutter Ponding | N/A | No | Curb Slope | 15.8 |

Remove & Replace Curb Ramp With Two New Directional Ramps or Equivalent.

R304.2.2, R304.5.3, STD 1115
