# Access Compliance Report Public Rights-of-Way (Curb Ramps)

Main Street: OCASO\_ST Cross Street: JARANO\_ST Location: NW

ADA ID: RPRK211124141545 Ramp Type: Type 1 - Perpendicular Diagonal Initial Pass/Fail: Pass Overall Compliance: No Severity Score: 0

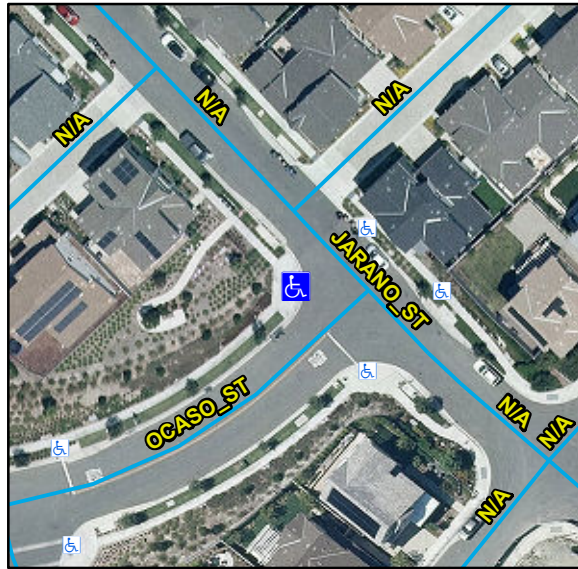
| Compliance | Description | Data | Compliance | Description | Data |
|---|---|---|---|---|---|
| No | Gutter Cross Slope (%) | 3.8 | | | |

Remove & Replace Gutter.
