# Access Compliance Report Public Rights-of-Way (Curb Ramps)

Main Street: JARANO\_ST Cross Street: OCASO\_ST Location: S

ADA ID: RPRK211124142930 Ramp Type: Type 1 - Perpendicular Diagonal Initial Pass/Fail: Fail Overall Compliance: No Severity Score: 2

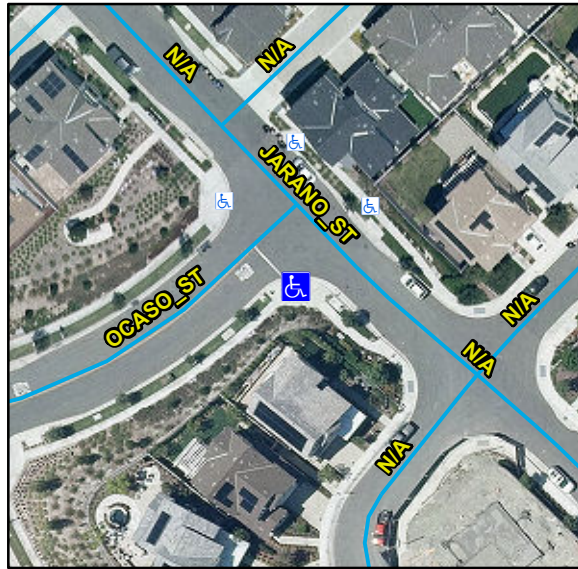
| Compliance | Description | Data | Compliance | Description | Data |
|---|---|---|---|---|---|
| No | Ramp Cross Slope (%) | 3.3 | N/A | Flare Traversable LT | N/A |

Remove & Replace Curb Ramp With Two New Directional Ramps or Equivalent.

R304.2.2, R304.5.3, STD 1115
