# Access Compliance Report Public Rights-of-Way (Curb Ramps)

| Main Street: AIROSO_ST | | Cross Street: OCASO_ST | | Location: | SW |
| ADA ID: RPRK211124143313 | Ramp Type:Type 1 - Perpendicular Diagonal Initial Pass/Fail: Fail | | Overall Compliance: No | Severity Score: | 15 |

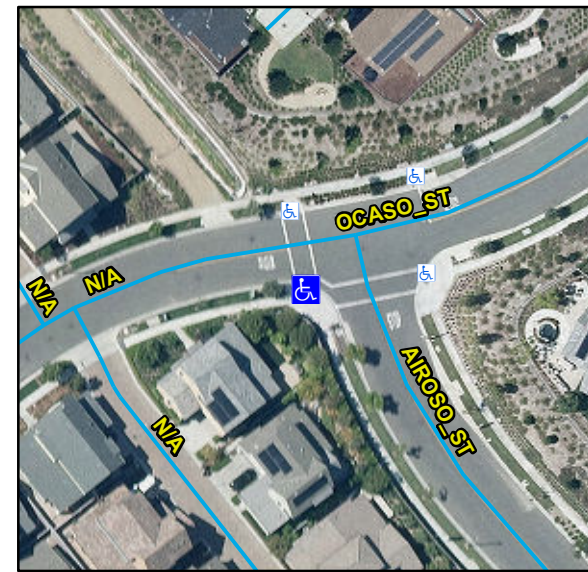
| Compliance | Description | Data | Compliance | Description | Data |
|---|---|---|---|---|---|
| No | Ramp Run Slope (%) | 9.4 | N/A | Flare Slope LT (%) | N/A |

Possible Solutions:

**Remove & Replace Curb Ramp With Two New Directional Ramps or Equivalent.**

**R304.2.2, STD 1115**
