# Access Compliance Report Public Rights-of-Way (Curb Ramps)

| Main Street: COW_CAMP_RD | | Cross Street: ESENCIA_DR | | Location: | SW |
| ADA ID: RPRK211129112007 | Ramp Type: Type 1 - Perpendicular | Initial Pass/Fail: Pass | Overall Compliance: No | Severity Score: | 10 |

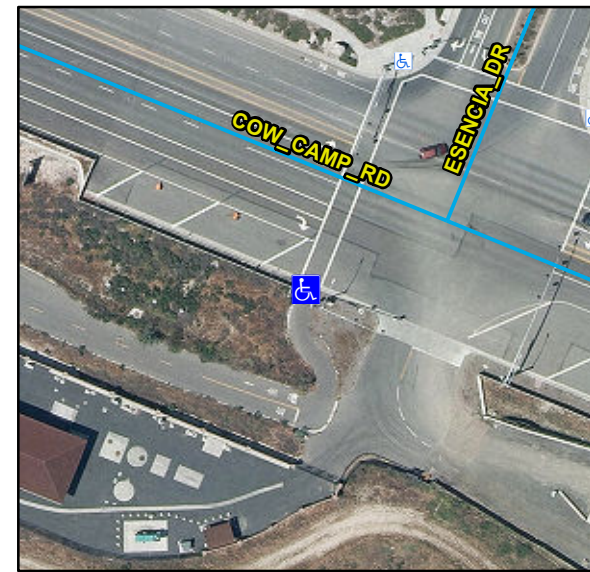
| Compliance | Description | Data | Compliance | Description | Data |
|---|---|---|---|---|---|
| No | Landing Width (in) | N/A | N/A | Flare Slope RT (%) | N/A |
| No | Landing Run Slope (%) | N/A | N/A | Flare Traversable RT | N/A |
| No | Landing Cross Slope (%) | N/A | Yes | DWS Provided | Yes |
| Yes | Gutter Ponding | No | No | Curb Slope | 12.2 |

Possible Solutions:

Remove & Replace Entire Ramp.
