# Access Compliance Report Public Rights-of-Way (Curb Ramps)

Main Street: COW\_CAMP\_RD Cross Street: ESENCIA\_DR Location: N

ADA ID: RPRK211129120505 Ramp Type: Type 1 - Perpendicular Diagonal Initial Pass/Fail: Fail Overall Compliance: No Severity Score: 15

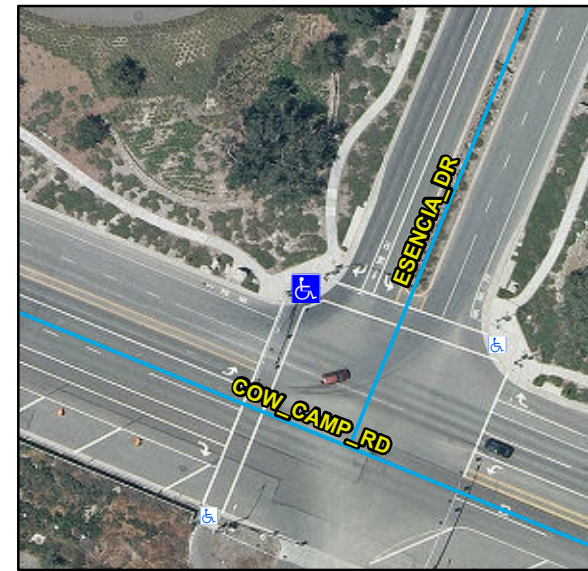
| Compliance | Description | Data | Compliance | Description | Data |
|---|---|---|---|---|---|
| No | Ramp Run Slope (%) | 11.6 | N/A | Flare Slope LT (%) | N/A |

Remove & Replace Curb Ramp With Two New Directional Ramps or Equivalent.

R304.2.2, STD 1115
