# Access Compliance Report Public Rights-of-Way (Curb Ramps)

Main Street: ANDAZA\_ST Cross Street: ESENCIA\_DR Location: E

ADA ID: RPRK211129122712 Ramp Type: Type 1 - Perpendicular Initial Pass/Fail: Pass Overall Compliance: No Severity Score: 0

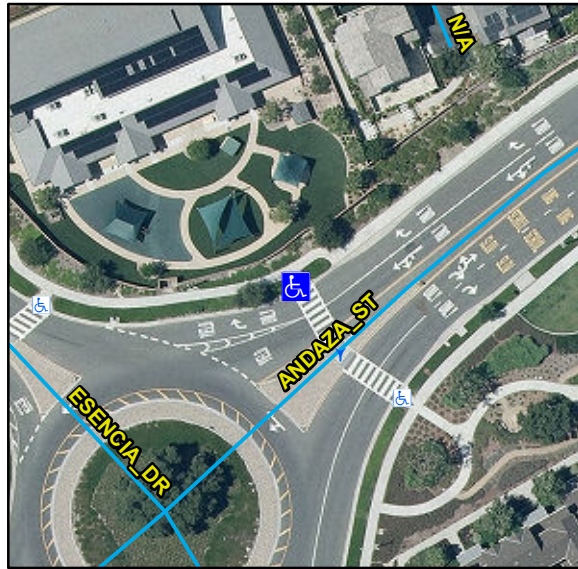
R304.2.2, R304.5.3, STD 1115

| Compliance | Description | Data | Compliance | Description | Data |
|---|---|---|---|---|---|
| No | Landing Cross Slope (%) | 2.6 | Yes | DWS Provided | Yes |
| Yes | Gutter Ponding | No | No | Curb Slope | 12.3 |

Remove & Replace Entire Ramp.

Total Cost: \$ 3080
