# Access Compliance Report Public Rights-of-Way (Curb Ramps)

Main Street: ESENCIA\_DR Cross Street: ANDAZA\_ST Location: NW

ADA ID: RPRK211129123519 Ramp Type: Type 1 - Perpendicular Initial Pass/Fail: Pass Overall Compliance: No Severity Score: 6

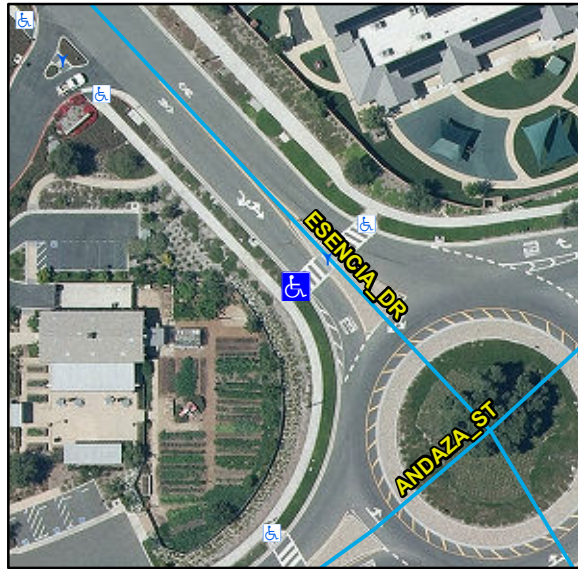
| Compliance | Description | Data | Compliance | Description | Data |
|---|---|---|---|---|---|
| No | Landing Run Slope (%) | 2.4 | N/A | Flare Traversable RT | No |
| Yes | Gutter Ponding | No | No | Curb Slope | 5.1 |
| No | Gutter Run Slope (%) | 5.4 | | Road Cross Slope (%) | N/A |

Remove & Replace Entire Ramp. Remove & Replace Gutter.

R304.2.2, R304.2.2-Perp, R304.3.2-Para, R304.5.4, STD 1115

Total Cost: \$ 3332
