# Access Compliance Report Public Rights-of-Way (Curb Ramps)

Main Street: ANDAZA\_ST Cross Street: ESENCIA\_DR Location: SW

ADA ID: RPRK211129124048 Ramp Type: Type 1 - Perpendicular Initial Pass/Fail: Pass Overall Compliance: No Severity Score: 0

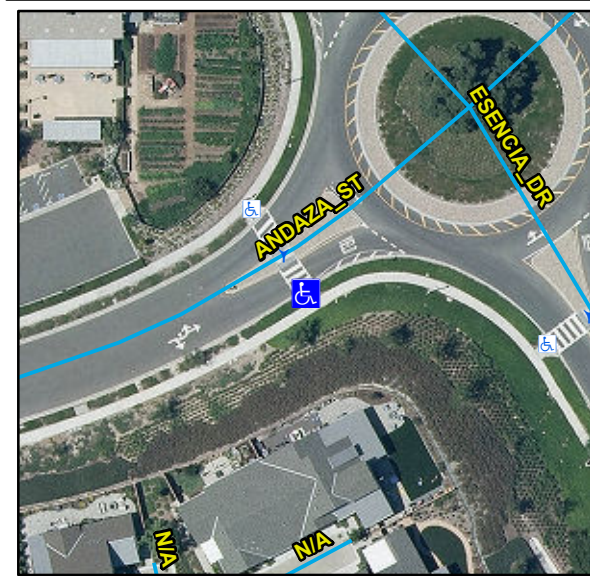
| Compliance | Description | Data | Compliance | Description | Data |
|---|---|---|---|---|---|
| Yes | Gutter Ponding | No | No | Curb Slope | 13.1 |

Possible Solutions:  
**Remove & Replace Curb Slope.**

OC Std/PROW:  
**R304.2.2, STD 1115**

Total Cost: \$ 252
