# Access Compliance Report Public Rights-of-Way (Curb Ramps)

Main Street: ESENCIA\_DR Cross Street: ANDAZA\_ST Location: SE

ADA ID: RPRK211129124640 Ramp Type: Type 1 - Perpendicular Initial Pass/Fail: Pass Overall Compliance: No Severity Score: 0

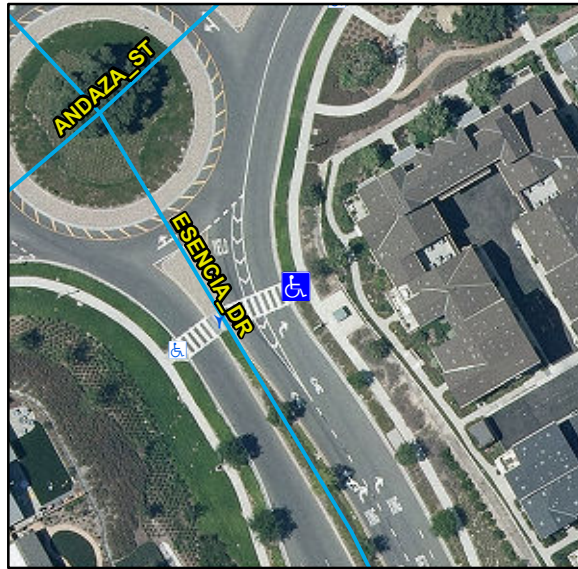
| Compliance | Description | Data | Compliance | Description | Data |
|---|---|---|---|---|---|
| Yes | Gutter Ponding | No | No | Curb Slope | 14.7 |

Remove & Replace Curb Slope.

R304.2.2, STD 1115
