# Access Compliance Report Public Rights-of-Way (Curb Ramps)

Main Street: N/A Cross Street: TIERNO\_RD Location: W

ADA ID: RPRK211129125447 Ramp Type: Type 4 - Parallel Initial Pass/Fail: Pass Overall Compliance: No Severity Score: 6

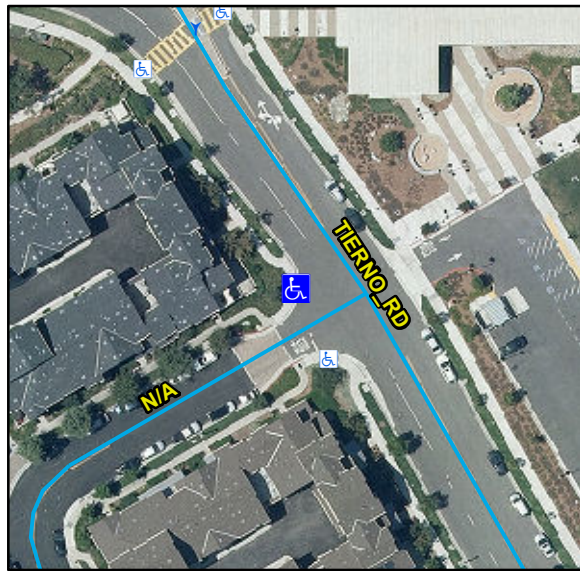
| Compliance | Description | Data | Compliance | Description | Data |
|---|---|---|---|---|---|
| No | Landing Cross Slope (%) | 2.8 | | DWS Offset Type | Single |
| No | Gutter Run Slope (%) | 6 | | Road Cross Slope (%) | 2.6 |
| No | Gutter Cross Slope (%) | 2.8 | Yes | Perpendicular Joint Present | Yes |

Remove & Replace Landing. Remove & Replace Gutter.

R304.5.3, R304.5.4, STD 1115
