# Access Compliance Report Public Rights-of-Way (Curb Ramps)

| Main Street: TIERNO_RD | | Cross Street: N/A | | Location: | W |
| ADA ID: RPRK211129125727 | Ramp Type: Type 4 - Parallel | Initial Pass/Fail: Fail | Overall Compliance: No | Severity Score: | 2 |

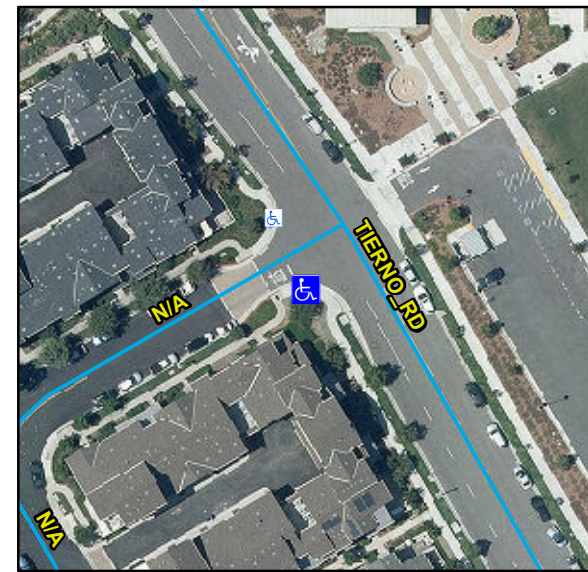
| Compliance | Description | Data | Compliance | Description | Data |
|---|---|---|---|---|---|
| No | Ramp Cross Slope LT (%) | 2.1 | Yes | Ramp Cross Slope RT (%) | 0.9 |

**Remove & Replace Curb Ramp With Two New Directional Ramps or Equivalent.**

**R304.5.3, STD 1115**

Total Cost: \$ 4000
