# Access Compliance Report Public Rights-of-Way (Curb Ramps)

Main Street: ANDAZA\_ST Cross Street: TIERNO\_RD Location: E

ADA ID: RPRK211129132252 Ramp Type: Type 1 - Perpendicular Initial Pass/Fail: Fail Overall Compliance: No Severity Score: 2

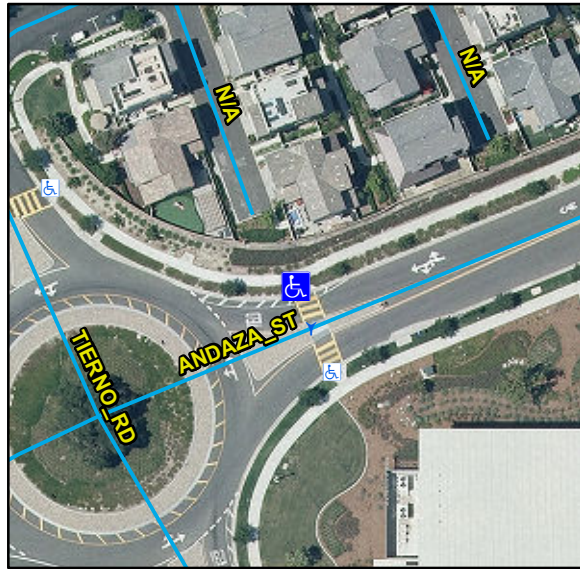
| Compliance | Description | Data | Compliance | Description | Data |
|---|---|---|---|---|---|
| No | Ramp Cross Slope (%) | 3.4 | N/A | Flare Traversable LT | N/A |
| N/A | Gutter Ponding | N/A | No | Curb Slope | 7.3 |

Possible Solutions:

Remove & Replace Entire Ramp.

R304.2.2, R304.5.3, STD 1115

\$ 3080
