# Access Compliance Report Public Rights-of-Way (Curb Ramps)

Main Street: TIERNO\_RD Cross Street: ANDAZA\_ST Location: N

ADA ID: RPRK211129132408 Ramp Type: Type 1 - Perpendicular Initial Pass/Fail: Pass Overall Compliance: No Severity Score: 0

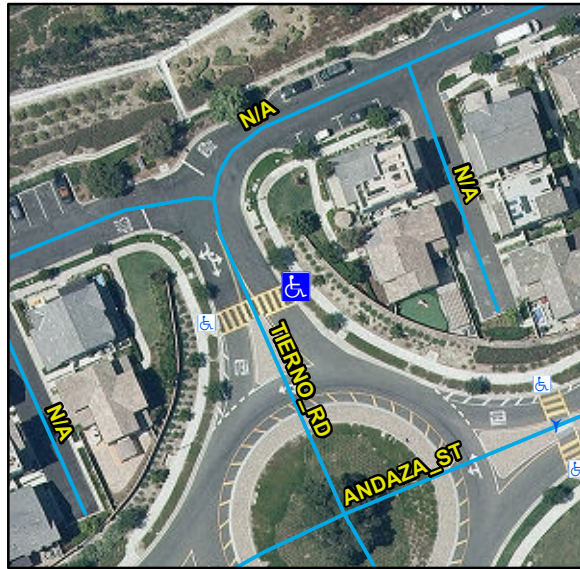
| Compliance | Description | Data | Compliance | Description | Data |
|---|---|---|---|---|---|
| Yes | Gutter Ponding | No | No | Curb Slope | 9.1 |

Remove & Replace Curb Slope.

R304.2.2, STD 1115

\$ 252
