# Access Compliance Report Public Rights-of-Way (Curb Ramps)

| Main Street: TIERNO_RD | | Cross Street: ANDAZA_ST | | Location: | N |
| ADA ID: RPRK211129132757 | Ramp Type:Type 1 - Perpendicular | Initial Pass/Fail: Fail | Overall Compliance: No | Severity Score: | 30 |

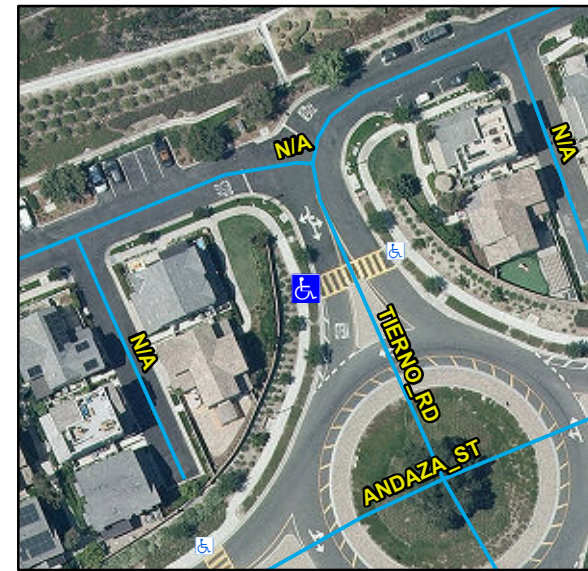
| Compliance | Description | Data | Compliance | Description | Data |
|---|---|---|---|---|---|
| No | Ramp Run Slope (%) | 15.7 | N/A | Flare Slope LT (%) | N/A |
| N/A | Gutter Ponding | N/A | No | Curb Slope | 18.3 |

Possible Solutions:

Remove & Replace Entire Ramp.

R304.2.2, STD 1115

\$ 3080
