# Access Compliance Report Public Rights-of-Way (Curb Ramps)

Main Street: **ANDAZA\_ST** Cross Street: **TIERNO\_RD** Location: **W**

ADA ID: **RPRK211129132906** Ramp Type: **Type 4 - Parallel** Initial Pass/Fail: **Fail** Overall Compliance: **No** Severity Score: **2**

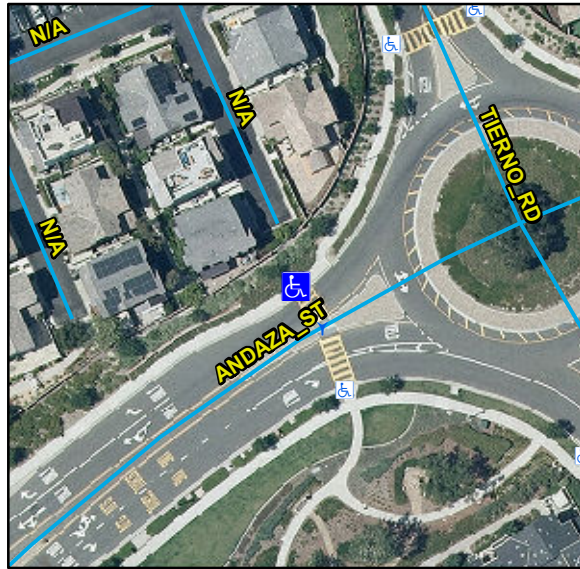
| Compliance | Description | Data | Compliance | Description | Data |
|---|---|---|---|---|---|
| <b>No</b> | Ramp Cross Slope LT (%) | <b>2.4</b> | <b>Yes</b> | Ramp Cross Slope RT (%) | <b>0.4</b> |
| <b>N/A</b> | Gutter Ponding | <b>N/A</b> | <b>No</b> | Curb Slope | <b>9.6</b> |

**Remove & Replace Entire Ramp.**

**R304.2.2, R304.5.3, STD 1115**
