# Access Compliance Report Public Rights-of-Way (Curb Ramps)

| Main Street: ANDAZA_ST | | Cross Street: BALIZA_RD | | Location: | SE |
| ADA ID: RPRK211129135125 | Ramp Type: Type 4 - Parallel | Initial Pass/Fail: Fail | Overall Compliance: No | Severity Score: | 32 |

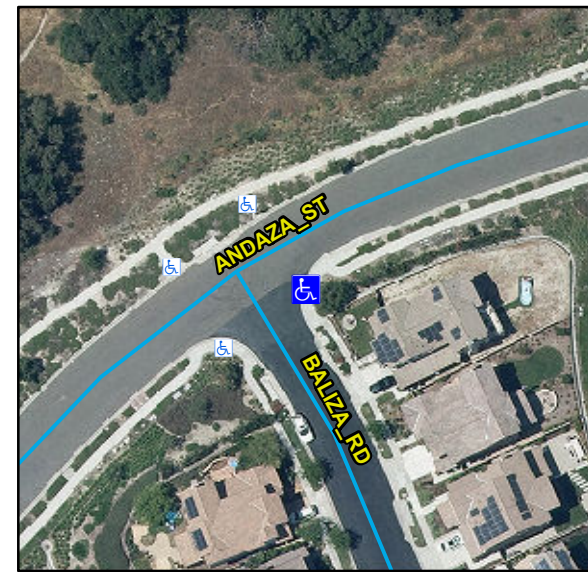
| Compliance | Description | Data | Compliance | Description | Data |
|---|---|---|---|---|---|
| No | Ramp Run Slope LT (%) | 15.7 | Yes | Ramp Run Slope RT (%) | 2.3 |
| No | Ramp Cross Slope LT (%) | 3.5 | Yes | Ramp Cross Slope RT (%) | 0.4 |

**Remove & Replace Curb Ramp With Two New Directional Ramps or Equivalent.**

**R304.3.2, R304.5.3, STD 1115**
