# Access Compliance Report Public Rights-of-Way (Curb Ramps)

| Main Street: BALIZA_RD | | Cross Street: ANDAZA_ST | | Location: | SW |
| ADA ID: RPRK211129135614 | Ramp Type: Type 4 - Parallel | Initial Pass/Fail: Fail | Overall Compliance: No | Severity Score: | 32 |

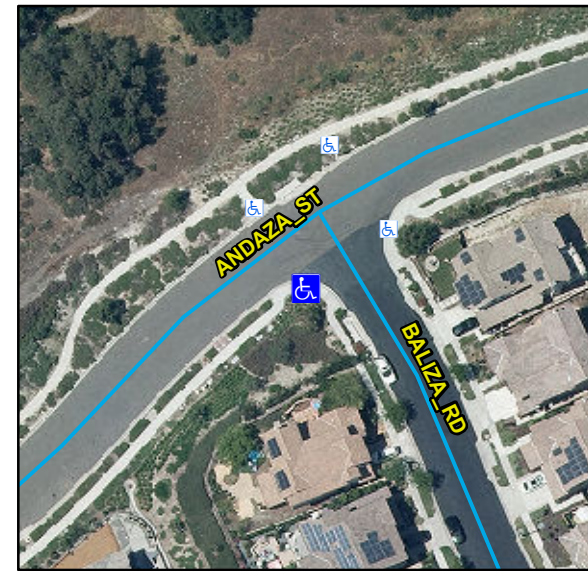
| Compliance | Description | Data | Compliance | Description | Data |
|---|---|---|---|---|---|
| No | Ramp Run Slope LT (%) | 15.8 | No | Ramp Run Slope RT (%) | 8.5 |

**Remove & Replace Curb Ramp With Two New Directional Ramps or Equivalent.**

**R304.3.2, STD 1115**

Total Cost: \$ 4000
