# Access Compliance Report Public Rights-of-Way (Curb Ramps)

Main Street: ANDAZA\_ST Cross Street: N/A Location: N

ADA ID: RPRK211129140100 Ramp Type: Type 4 - Parallel Initial Pass/Fail: Fail Overall Compliance: No Severity Score: 32

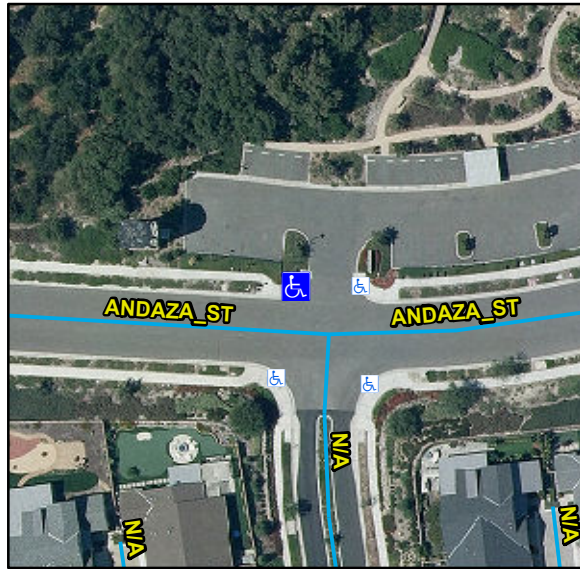
| Compliance | Description | Data | Compliance | Description | Data |
|---|---|---|---|---|---|
| Yes | Ramp Run Slope LT (%) | 6.1 | No | Ramp Run Slope RT (%) | 15.5 |
| Yes | Ramp Cross Slope LT (%) | 0 | No | Ramp Cross Slope RT (%) | 2.3 |

Remove & Replace Curb Ramp With Two New Directional Ramps or Equivalent.

R304.3.2, R304.5.3, STD 1115
