# Access Compliance Report Public Rights-of-Way (Curb Ramps)

Main Street: N/A Cross Street: ANDAZA\_ST Location: SW

ADA ID: RPRK211129140329 Ramp Type: Type 4 - Parallel Initial Pass/Fail: Fail Overall Compliance: No Severity Score: 2

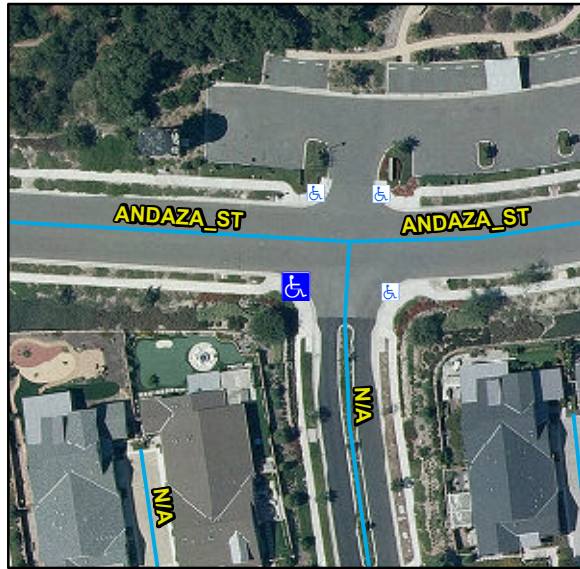
| Compliance | Description | Data | Compliance | Description | Data |
|---|---|---|---|---|---|
| No | Ramp Cross Slope LT (%) | 3.4 | No | Ramp Cross Slope RT (%) | 2.9 |

Remove & Replace Curb Ramp With Two New Directional Ramps or Equivalent.

R304.5.3, STD 1115
