# Access Compliance Report Public Rights-of-Way (Curb Ramps)

Main Street: ANDAZA\_ST Cross Street: N/A Location: SE

ADA ID: RPRK211129140529 Ramp Type: Type 4 - Parallel Initial Pass/Fail: Fail Overall Compliance: No Severity Score: 32

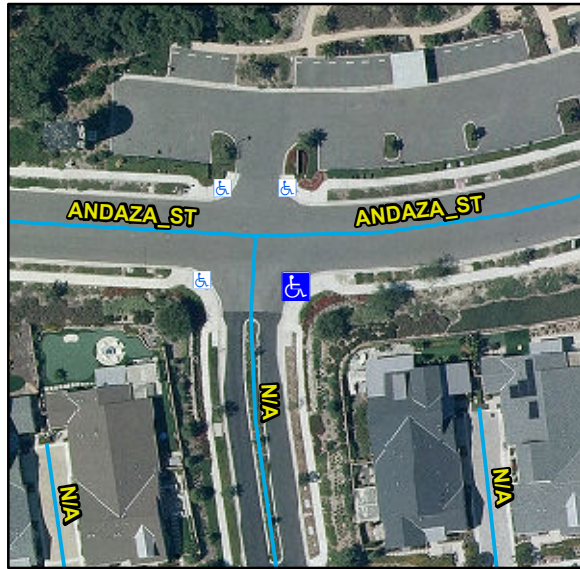
| Compliance | Description | Data | Compliance | Description | Data |
|---|---|---|---|---|---|
| Yes | Ramp Run Slope LT (%) | 2.1 | No | Ramp Run Slope RT (%) | 14.6 |
| No | Ramp Cross Slope LT (%) | 2.4 | No | Ramp Cross Slope RT (%) | 2.4 |

Remove & Replace Curb Ramp With Two New Directional Ramps or Equivalent.

R304.5.3, R304.3.2, STD 1115

Total Cost: \$ 4000
