# Access Compliance Report Public Rights-of-Way (Curb Ramps)

Main Street: N/A Cross Street: ANDAZA\_ST Location: N

ADA ID: RPRK211129140744 Ramp Type: Type 4 - Parallel Initial Pass/Fail: Pass Overall Compliance: No Severity Score: 5

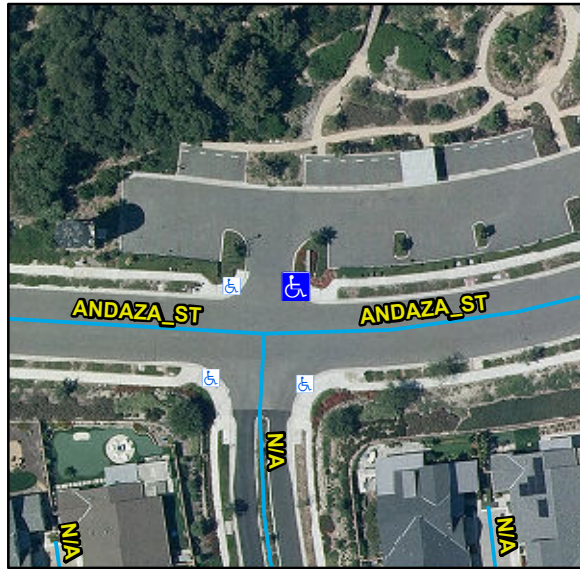
| Compliance | Description | Data | Compliance | Description | Data |
|---|---|---|---|---|---|
| No | Gutter Run Slope (%) | 5.7 | | Road Cross Slope (%) | 1 |

Remove & Replace Gutter.

R304.5.4, STD 1115
