# Access Compliance Report Public Rights-of-Way (Curb Ramps)

Main Street: AIROSO\_ST Cross Street: ESENCIA\_DR Location: SW

ADA ID: RPRK211129142538 Ramp Type: Type 1 - Perpendicular Diagonal Initial Pass/Fail: Fail Overall Compliance: No Severity Score: 16

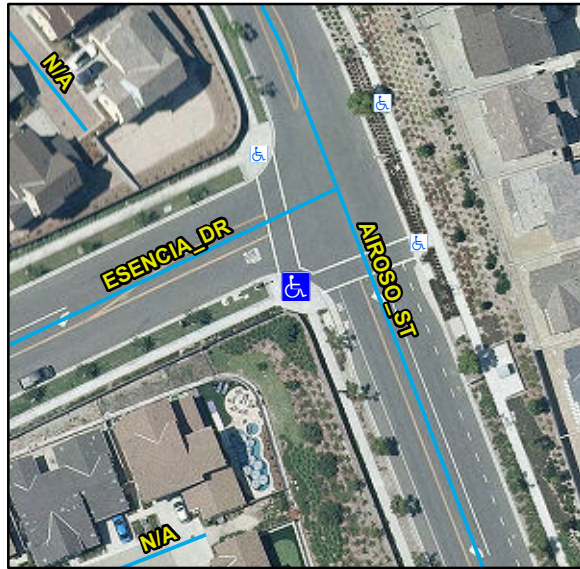
| Compliance | Description | Data | Compliance | Description | Data |
|---|---|---|---|---|---|
| No | Ramp Run Slope (%) | 9.6 | N/A | Flare Slope LT (%) | N/A |
| No | Ramp Cross Slope (%) | 2.5 | N/A | Flare Traversable LT | N/A |

**Remove & Replace Curb Ramp With Two New Directional Ramps or Equivalent.**

**R304.2.2, R304.5.3, STD 1115**
