Access Compliance Report Public Rights-of-Way (Curb Ramps)

Main Street: **ESENCIA_DR** Cross Street: **AIROSO_ST** Location: **NW**

ADA ID: **RPRK211129142715** Ramp Type: **Type 1 - Perpendicular** Initial Pass/Fail: **Pass** Overall Compliance: **No** Severity Score: **0**

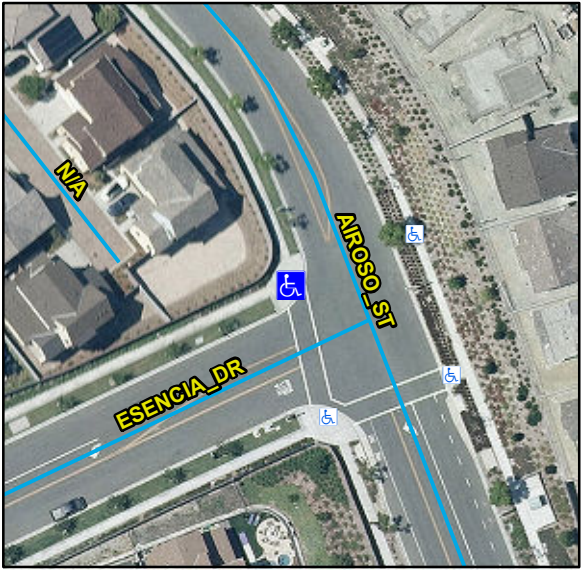
Compliance	Description	Data	Compliance	Description	Data
N/A	Ramp Length (in)	128	N/A	Flare Type LT	
Yes	Ramp Width (in)	48			Sloped
Yes	Ramp Run Slope (%)	3.1	N/A	Flare Slope LT (%)	6.7
Yes	Ramp Cross Slope (%)	0.7	N/A	Flare Traversable LT	No
N/A	Landing Present	Yes	N/A	Flare Type RT	
N/A	Landing Length (in)	53			Sloped
Yes	Landing Width (in)	48	N/A	Flare Slope RT (%)	0.8
Yes	Landing Run Slope (%)	0.7	N/A	Flare Traversable RT	No
Yes	Landing Cross Slope (%)	0.2	Yes	DWS Provided	Yes
N/A	Landing Movement Obstructed?	No	Yes	DWS Contrast	Yes
	Landing Movement Type	N/A	Yes	DWS Length (in)	36
N/A	Landing Shared	No	Yes	DWS Full Width	Yes
N/A	Clear Space	N/A	Yes	DWS Offset Left (in)	1
N/A	Clear Space To Crosswalk (in)	N/A	Yes	DWS Offset Right (in)	N/A
N/A	Marked Crosswalk 1	Yes	N/A	Marked Crosswalk 2	N/A
	Crossing 1 Direction	S		Crossing 2 Direction	N/A
	Marked Crosswalk 1 Width (in)	144		Marked Crosswalk 2 Width (in)	N/A

Yes	Ramp Inside Crosswalk 1	Yes	Yes	Ramp Inside Crosswalk 2	N/A
	Crossing 1 Slope (%)	2.6		Crossing 2 Slope (%)	N/A
	Crossing 1 Cross Slope (%)	1.1		Crossing 2 Cross Slope (%)	N/A
Yes	Gutter Ponding	No	No	Curb Slope	10.2
Yes	Gutter Lip Height (in)	0		Road Run Slope (%)	N/A
Yes	Gutter Run Slope (%)	1.5		Road Cross Slope (%)	N/A
No	Gutter Cross Slope (%)	2.4			
Yes	Overall Surface Condition: Acceptable		Yes	Perp Joint Present	Yes
	Cross Gutter Present?	No		Spandrel Present?	No
	Replace Cross Gutter?	N/A		Replace Spandrel?	N/A

Possible Solutions:
Remove & Replace Curb Slope. Remove & Replace Gutter.

OC Std/PROW:
R304.2.2, R304.5.3, STD 1115
