# Access Compliance Report Public Rights-of-Way (Curb Ramps)

Main Street: ESENCIA\_DR Cross Street: N/A Location: SE

ADA ID: RPRK211129143338 Ramp Type: Type 1 - Perpendicular Diagonal Initial Pass/Fail: Fail Overall Compliance: No Severity Score: 2

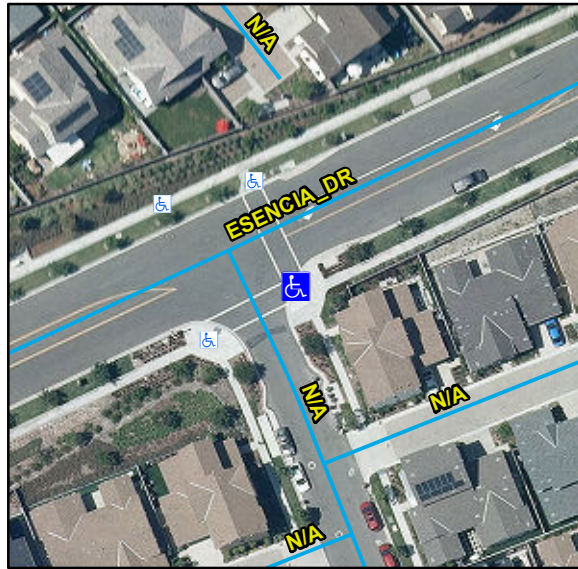
| Compliance | Description | Data | Compliance | Description | Data |
|---|---|---|---|---|---|
| No | Ramp Cross Slope (%) | 2.2 | N/A | Flare Traversable LT | N/A |

Remove & Replace Curb Ramp With Two New Directional Ramps or Equivalent.

R304.2.2, R304.5.3, STD 1115
