# Access Compliance Report Public Rights-of-Way (Curb Ramps)

Main Street: LOS PATRONES PKWY Cross Street: COW CAMP RD Location: E

ADA ID: RPRK211130112927 Ramp Type: Type 1 - Perpendicular Initial Pass/Fail: Pass Overall Compliance: No Severity Score: 0

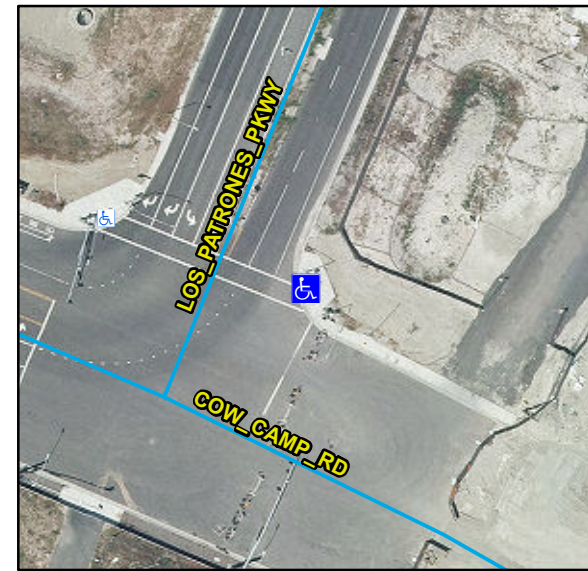
| Compliance | Description | Data | Compliance | Description | Data |
|---|---|---|---|---|---|
| Yes | Gutter Ponding | No | No | Curb Slope | 5.1 |

Remove & Replace Curb Slope.

R304.2.2, STD 1115
